**Therese McAllister**

# 7 Peripheral Buildings

## 7.1 Introduction

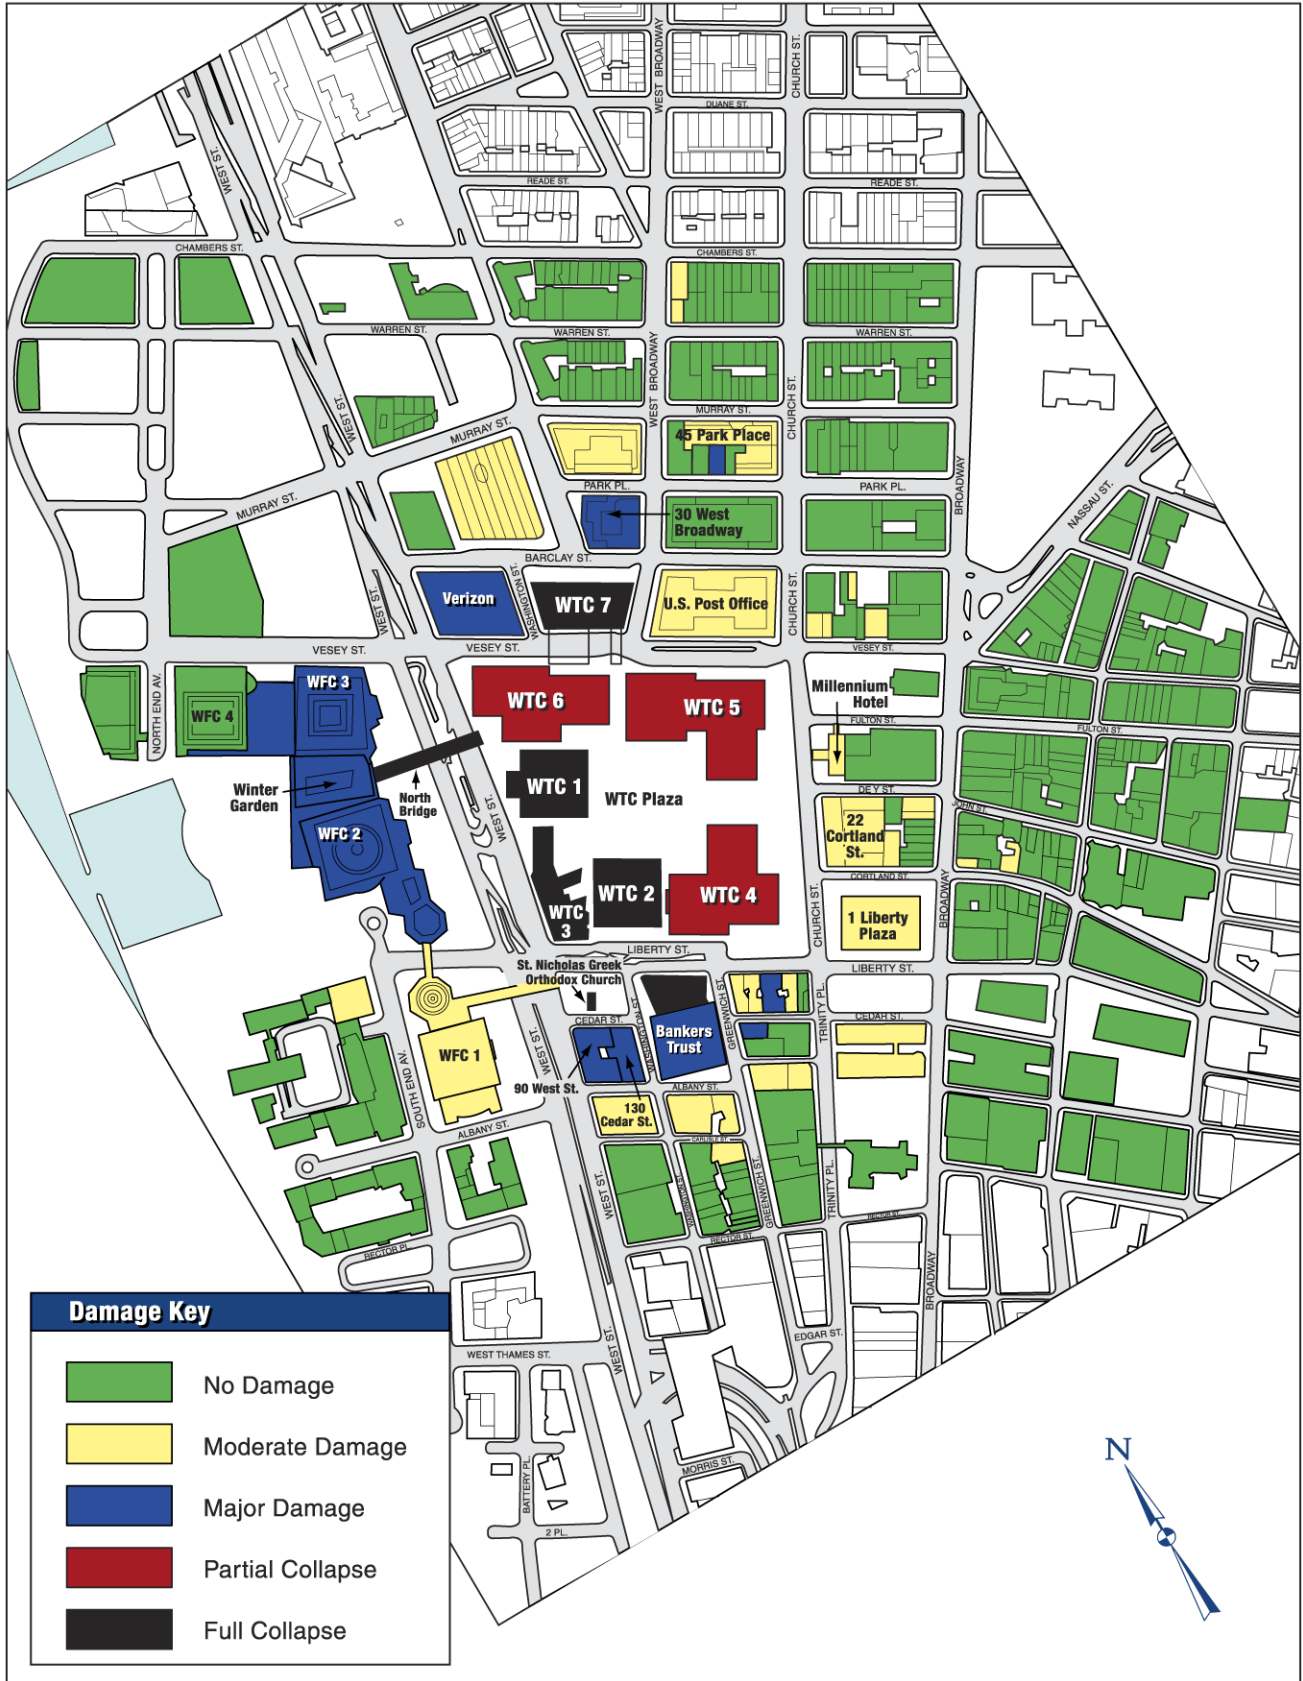
The building assessments were compared and coordinated with a parallel inspection performed by DoB and are summarized in Figure 7-1 and Table 7.1 according to the following color coding:

Figure 7-1 New York City DDC/DoB Cooperative Building Damage Assessment Map of November 7, 2001 (based on SEAoNY inspections of September and October 2001).

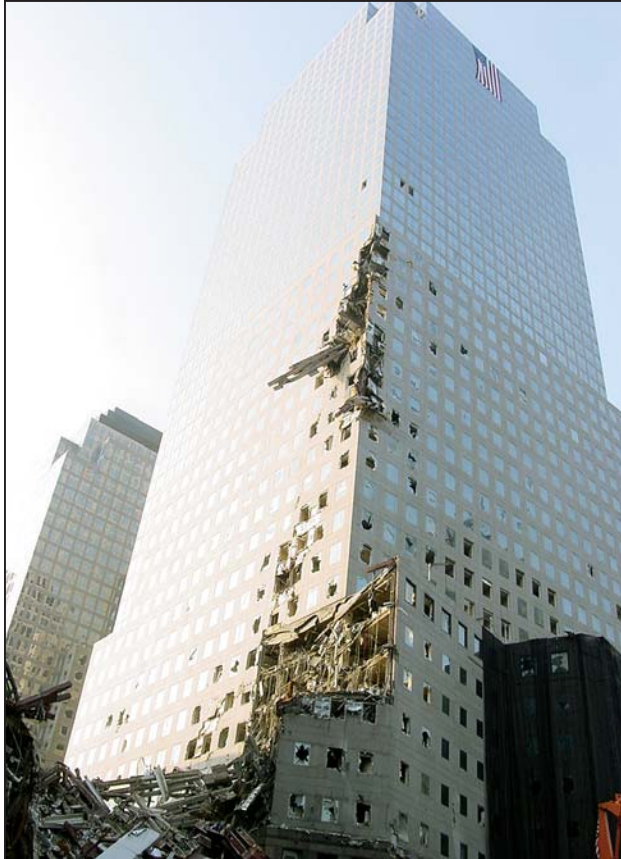
The 50-story WFC 3 building has a plan area of approximately 200 feet by 250 feet. Exterior column trees from WTC 1 were found hanging from the southeast corner of WFC 3 (Figure 7-2) and on the setback roof and against the east face of the Winter Garden (Figures 7-3 and 7-4). The impact of exterior column trees caused structural damage in both structures. Building faces not directly oriented toward the WTC site suffered minimal damage, even at the close proximity of several hundred yards.

Figure 7-2 Southeast corner of WFC 3.

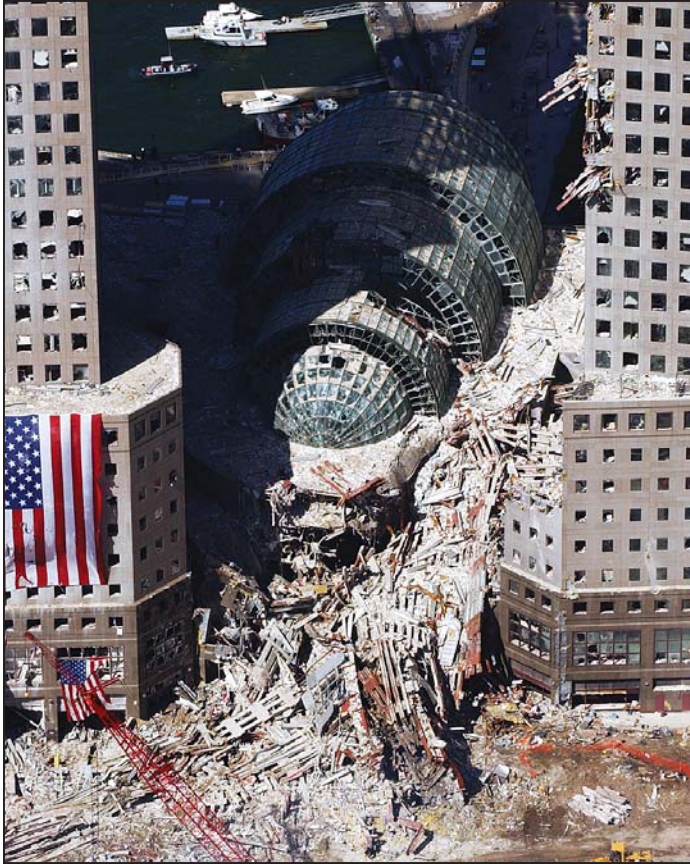
Columns from WTC 1 hit the east end of the structure, particularly the area directly adjacent to the North Bridge. The Winter Garden experienced severe collapse of the eastern end framing. Several other semicircular trusses and parts of the dome were also badly damaged. The western two bays of the roof structure remained intact, but were covered with debris. Inspectors estimated that 60 percent of the roofing glass panels of the structure had collapsed.

*Figure 7-3*  
View of Winter Garden damage from West Street, with WTC 1 debris in front of WFC 2.

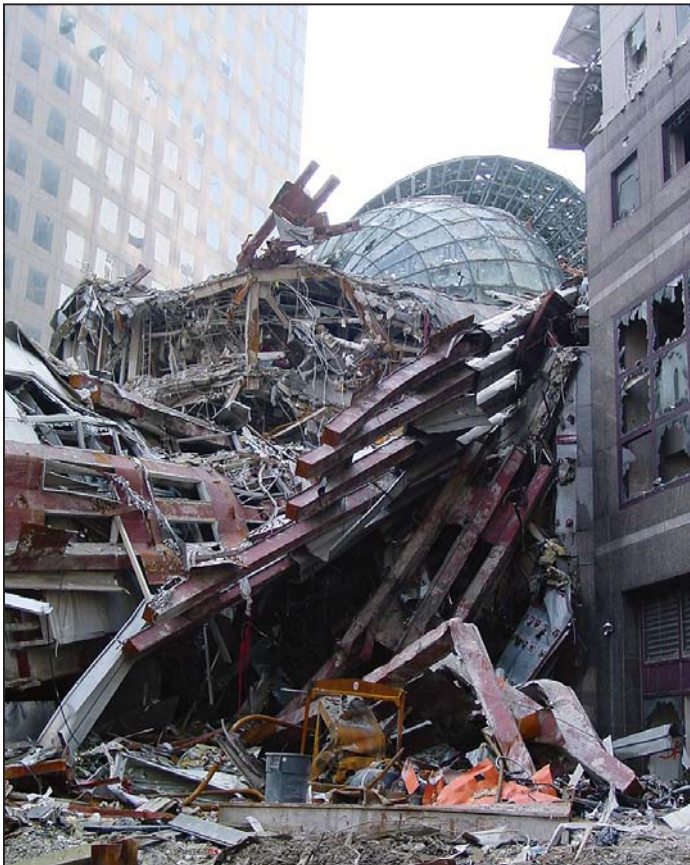
As the eastern roof trusses were sheared in several places, support was provided only by the transverse plate girders that remained in place. These conditions, coupled with the shearing of trussed arch framing, led the first round of inspectors to conclude that the structure was potentially unstable, and a rating of Partial Collapse was assigned. After installation of shoring, a new evaluation of the building led engineers to determine that the building was repairable, and the rating was revised to Major Damage.

*Figure 7-4*  
View of Winter Garden damage from West Street, with WTC 1 debris leaning against WFC 3.

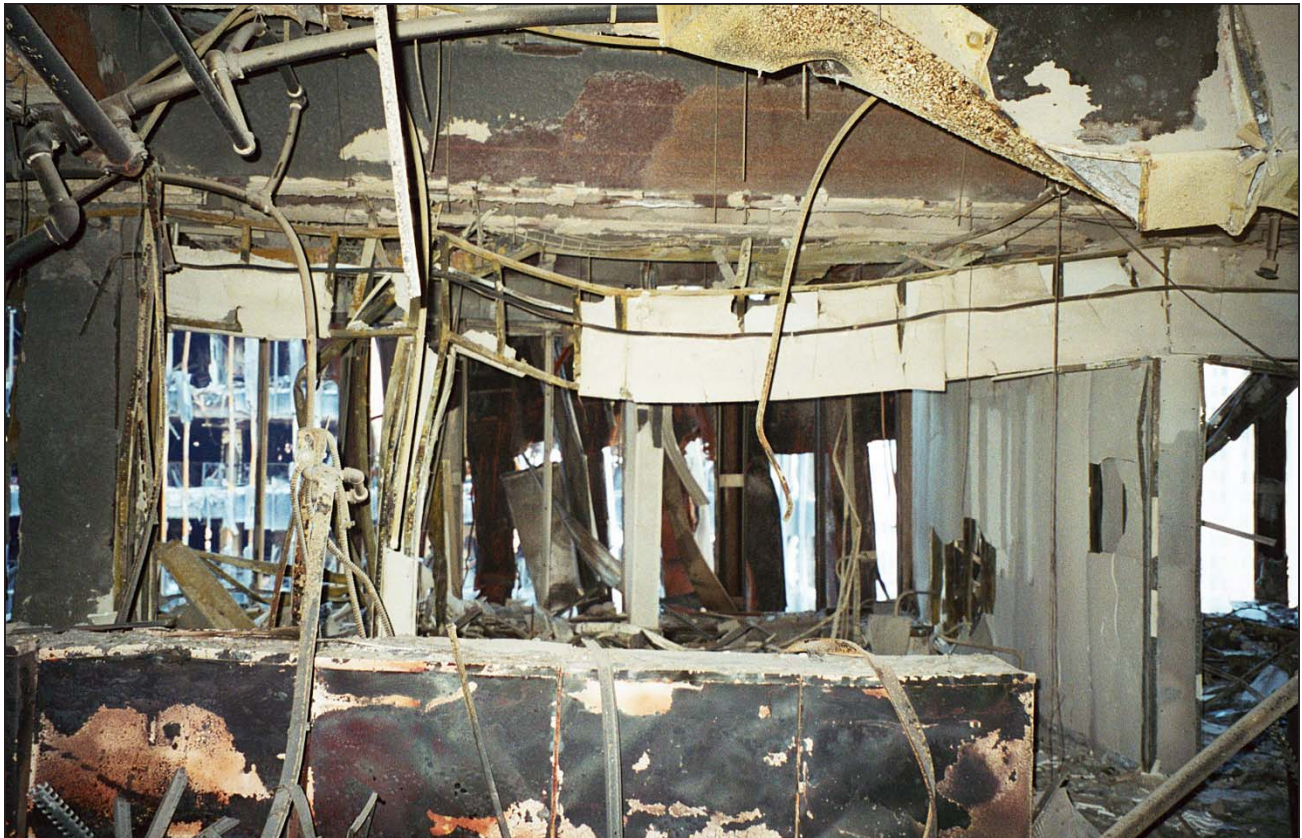
Interior damage is shown in Figure 7-5. Inspection of the interior determined that steel framing members that sustained direct impact from large debris had significant portions of the cementitious fireproofing material knocked off. The fireproofing was intact on adjacent steel members that had not been directly hit.

The localized nature of the damage, given the size of projectiles that impacted the building, is notable. Observations noted small welds between column end bearing plates at exterior and interior columns, indicating the columns near the damage zone were designed for gravity loads, and tension loads from wind were not a critical design parameter. This type of connection between columns may have allowed a column member to be knocked out of place without causing substantial displacement or damage to connecting framing.

Figure 7-5 Interior damage at floor 20 of WFC 3.

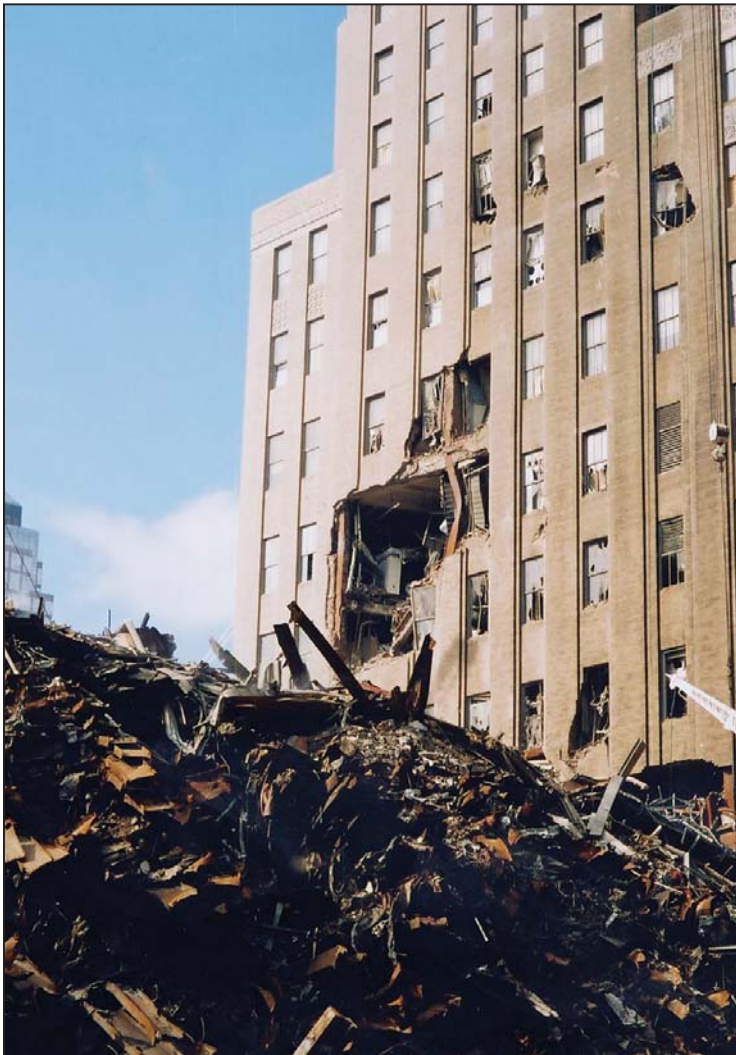
The east (Washington Street) side of the building was damaged from about the 9th floor down, primarily due to the impact of debris sliding out from the base of WTC 7 (Figures 7-6, 7-7, and 7-8). Some damage may have also been caused by WTC 1 debris. In addition to fairly extensive façade damage (bricks and windows), there was damage to two bays of slab and framing at the 1st, 4th, and 7th floors and to one

bay of slab and framing (including spandrel beam) at the 1st floor mezzanine and at the 5th floor. Two exterior columns suffered major damage between the 1st and 2nd floors (Figure 7-9), one exterior column suffered minor damage between the 3rd and 5th floors, and two exterior columns suffered major damage between the 6th and 8th floors. In addition, one interior column suffered minor damage below the 7th floor.

*Figure 7-6*  
*Verizon building – damage to east elevation*  
*(Washington Street).*

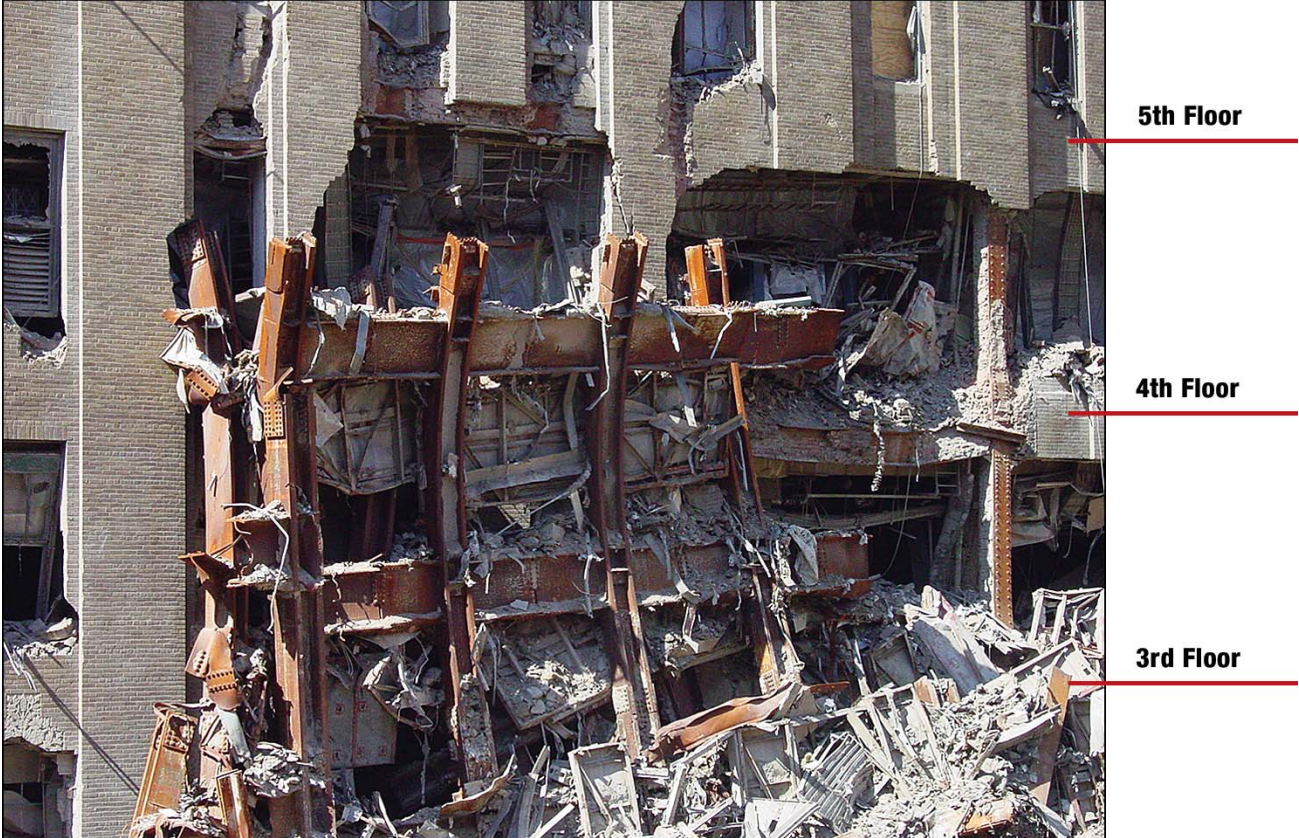
Figure 7-7 Verizon building – damage to east elevation (Washington Street) due to WTC 7 framing leaning against the building.

On the east (Washington Street) side of the building, most of the damage appeared to be due to the lateral pressure of the spreading debris at the base of WTC 7 (Figure 7-7). Two of the columns between the 1st and 2nd floors were deflected into the building by as much as 2 feet (with most of the rotation occurring at the column splice just above the 1st floor); at one of the columns, very little contact remained at the column splice (Figure 7-9). Even so, the columns did not buckle, and structural bays above did not collapse or deflect significantly. Similarly, the structural bays supported by the column between the 6th and 8th floors that was completely destroyed by the impact of projectile debris were essentially undamaged.

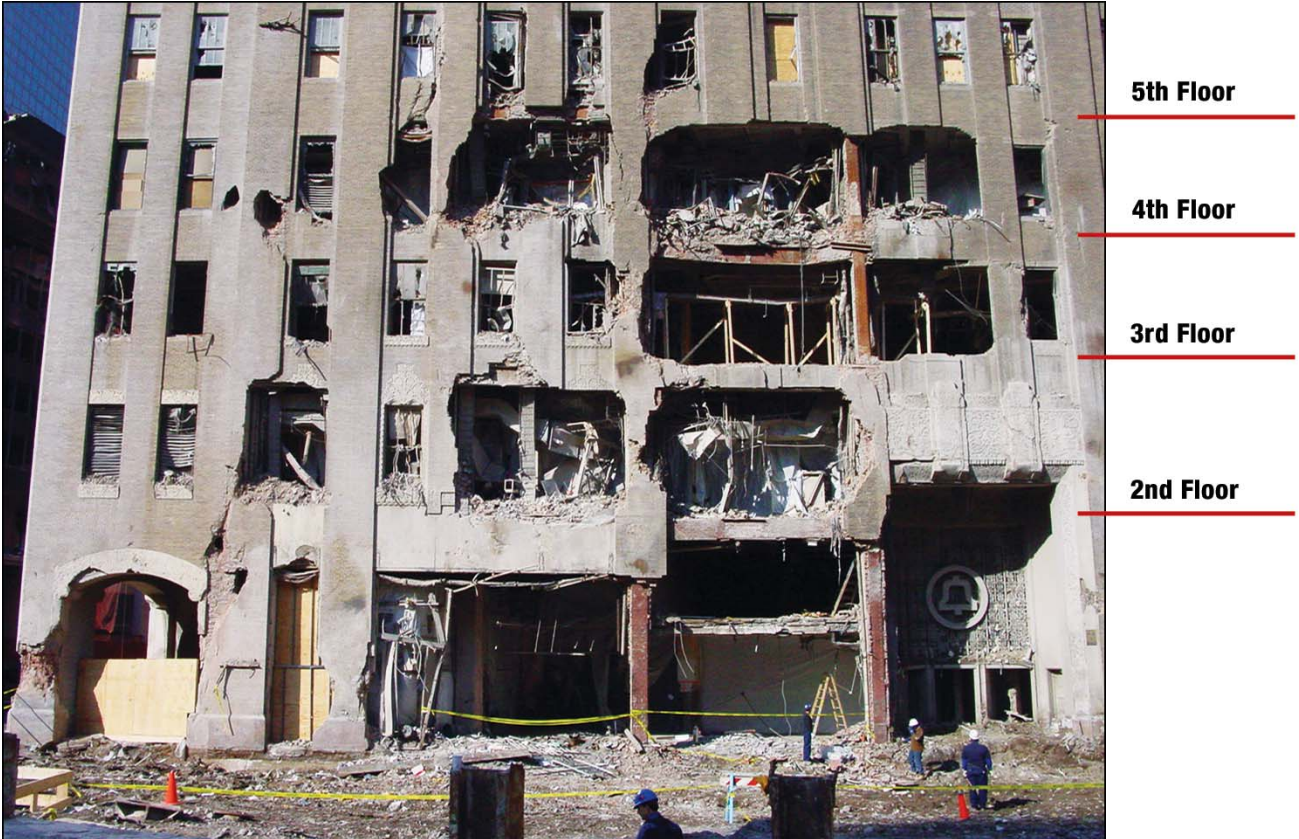
Figure 7-8 Verizon building – damage to east elevation (Washington Street).

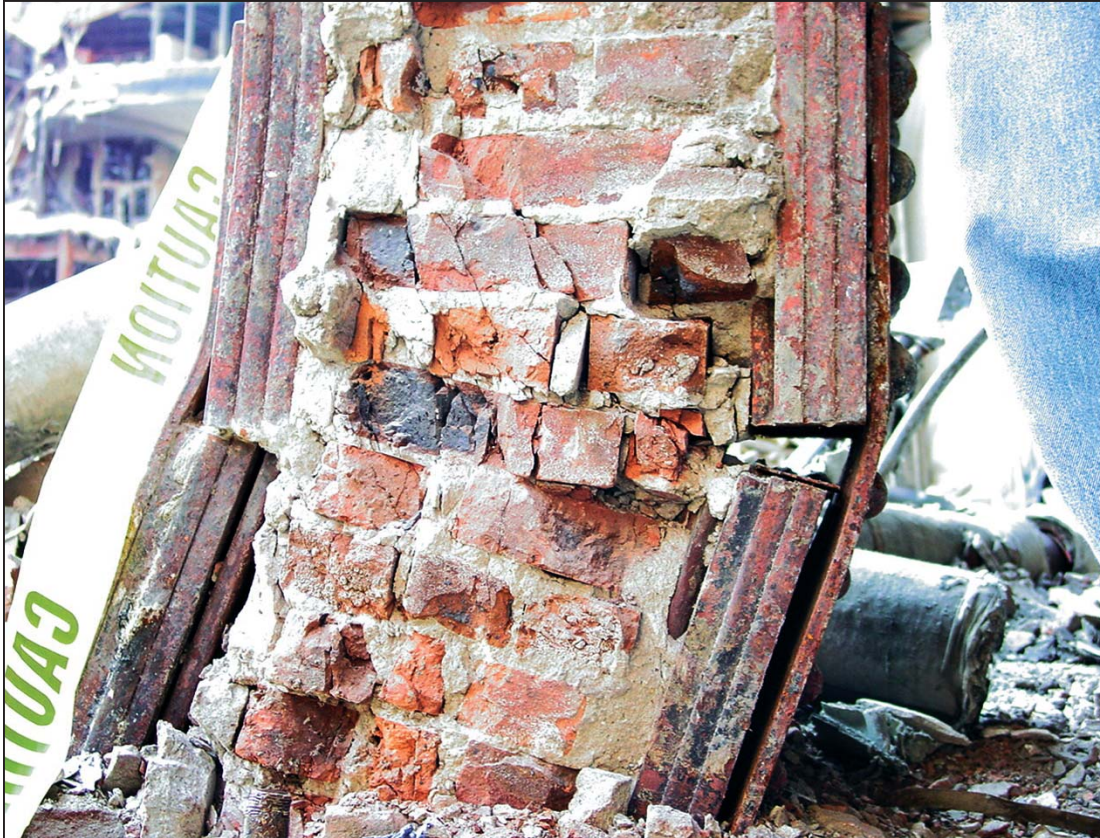
Figure 7-9 Verizon building – column damage on east elevation (Washington Street).

None of the damage to the floor framing threatened the structural integrity of the building. Although the damaged columns were deflected out-of-plane, it was determined that the columns were stable and not in danger of imminent collapse.

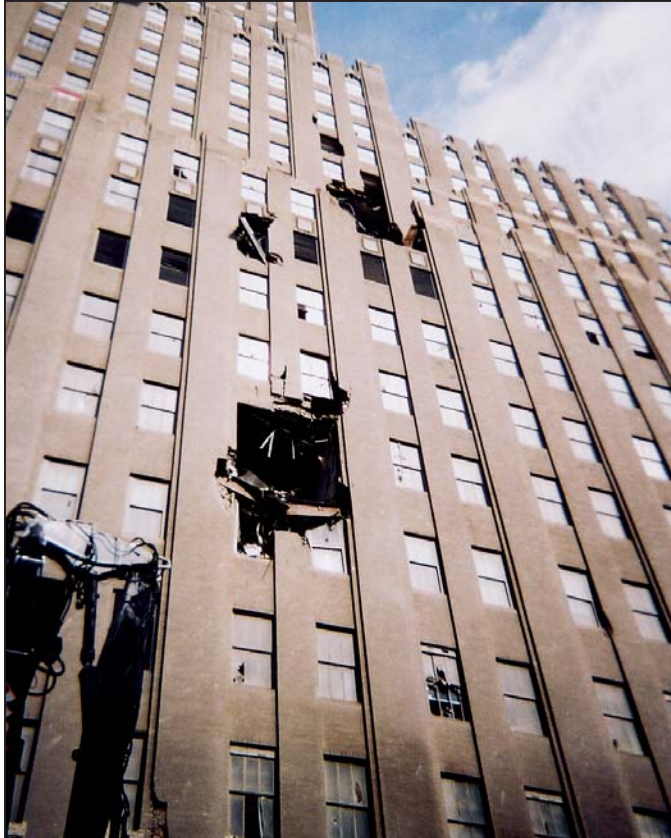
The south (Vesey Street) side of the building was damaged from approximately the 13th floor down, primarily due to the impact of projectile debris from the collapse of WTC 1 (Figure 7-10). In addition to fairly extensive façade damage (bricks and windows), two bays of slab and framing were damaged at the sidewalk arcade at the 1st floor, and one bay of slab and framing (including spandrel beams) was damaged at the 6th, 7th, 9th, 11th, 12th, and 13th floors (Figures 7–11 and 7-12). In addition, one interior column suffered minor damage below the 1st floor.

*Figure 7-10*  
Verizon building – damage to south elevation (Vesey Street).

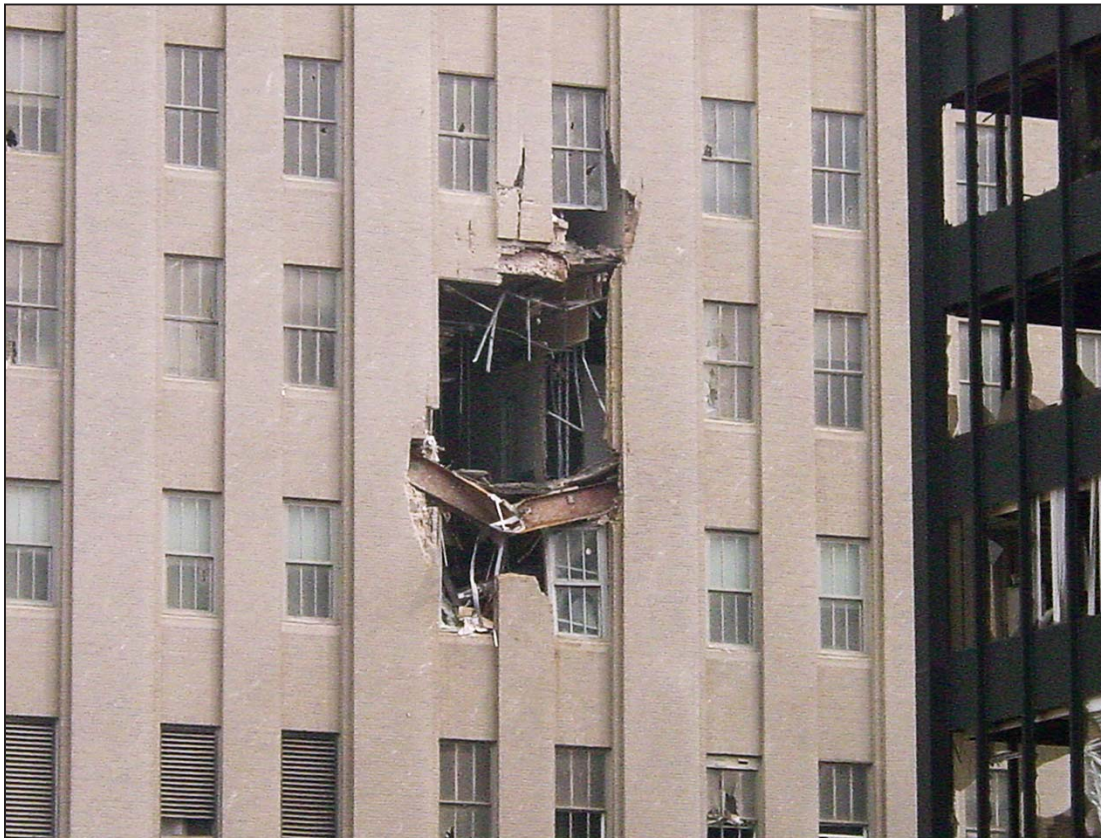
In general, the Verizon building performed well, especially given its close proximity to WTC 7. On the south (Vesey Street) side of the building, damage was extremely localized near the point of impact of projectile debris. In some cases, only a short section of spandrel beam and small area of floor slab were damaged, leaving the remainder of the structural bay intact (Figure 7-12).

*Figure 7-11* Verizon building – localized damage to south elevation (Vesey Street).

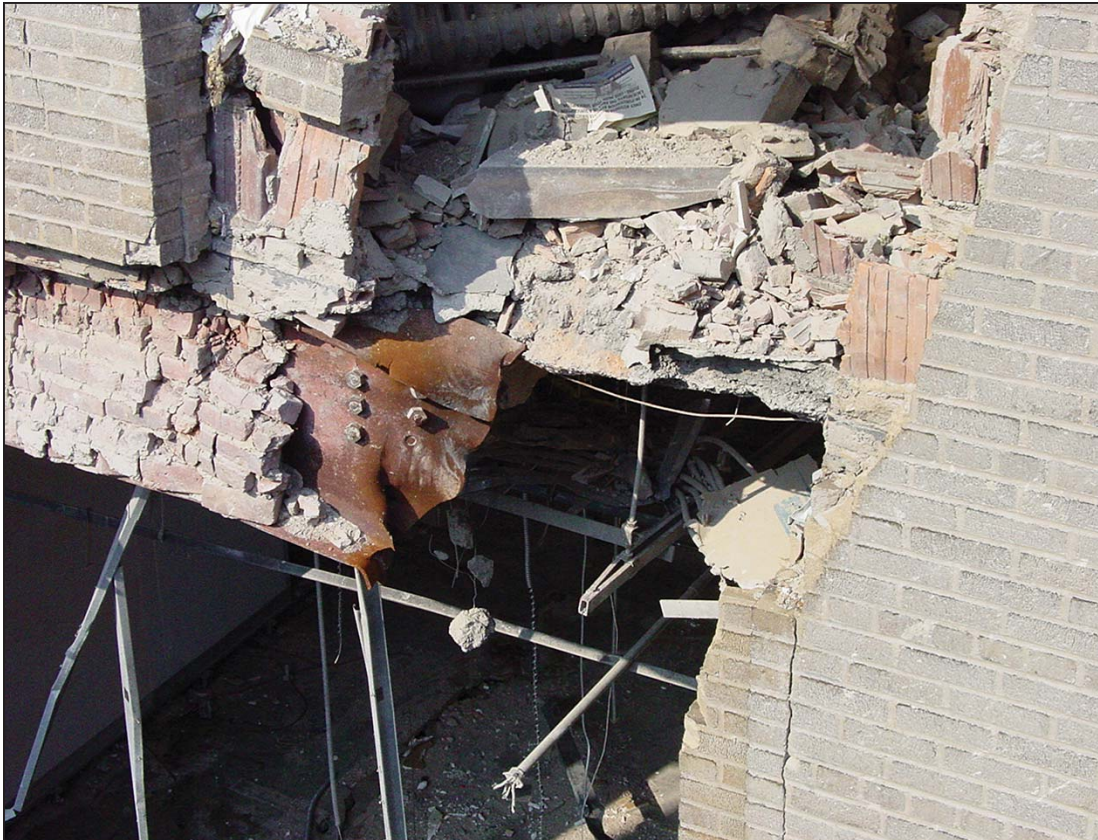
Figure 7-12 Verizon building – detail of damage to south elevation (Vesey Street).

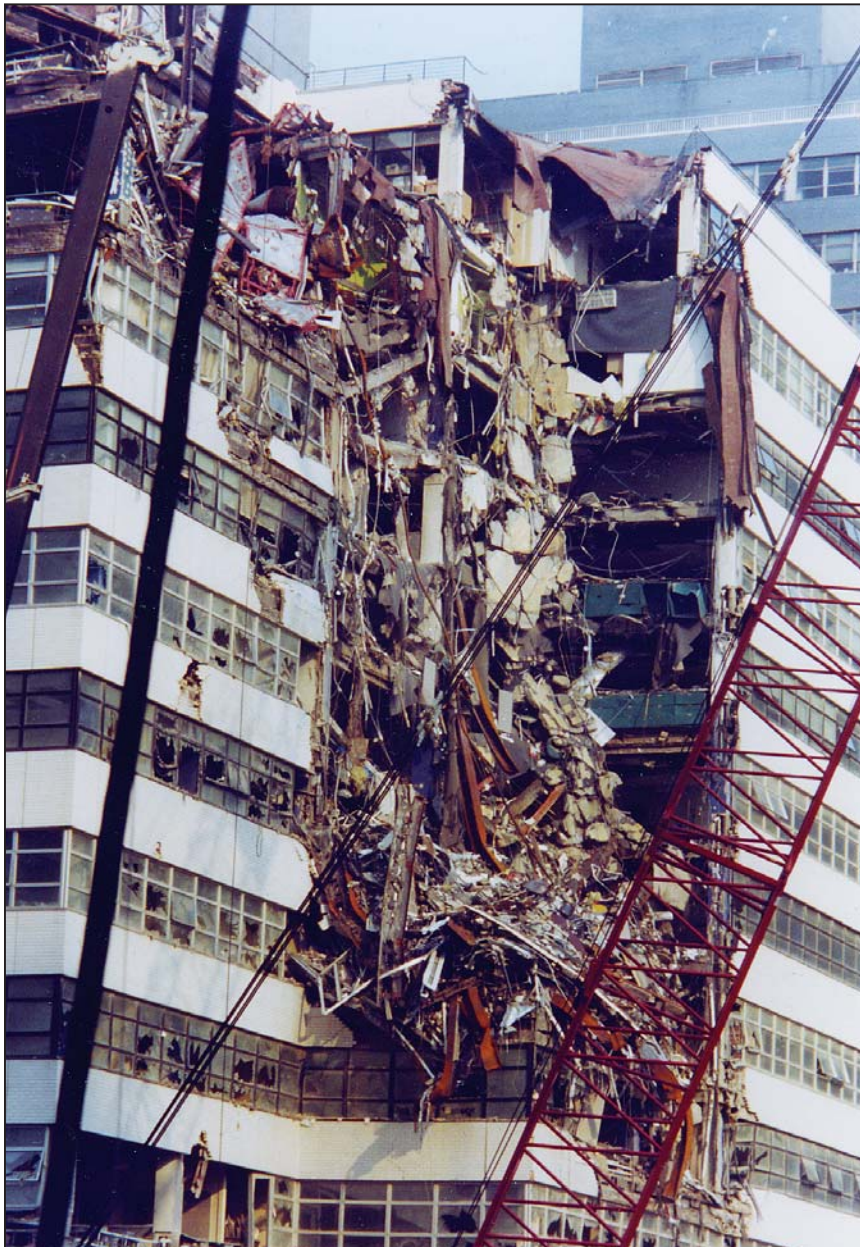
The southern half of the west façade and most of the south façade were severely damaged or destroyed. The south face of the building suffered structural damage in the exterior bay from impact by large debris from WTC 7 (Figure 7-13). There was no damage to the east and north faces of the building, and no fire in the building, even though there was a substantial fire in WTC 7.

*Figure 7-13*  
30 West Broadway – south façade, 6th floor to roof, looking northeast.

Damage was concentrated along the south face at and below the setback at the 15th floor. Portions of the south façade from the 15th floor collapsed. A vertical section of the perimeter wall extending five floors down from the setback at the center of the south façade was raked away. Local collapse also occurred at the southwest corner. The majority of the glass panes were knocked out on the south façade, in a triangular pattern that extended to the full width of the base. The south side of the building was unstable and required bracing. Floors 9 through 14 had two collapsed bays, and floors 3 through 6 had up to three collapsed bays. No structural damage was observed one bay away from the impact damage.

Floors 9 through 14 had at least two collapsed exterior bays and floors 3 through 6 had at least three collapsed exterior bays. There was relatively little damage at the 7th floor. A considerable amount of debris was on the 8th floor. The steel beams supporting two bays of this floor yielded, but are still in place.

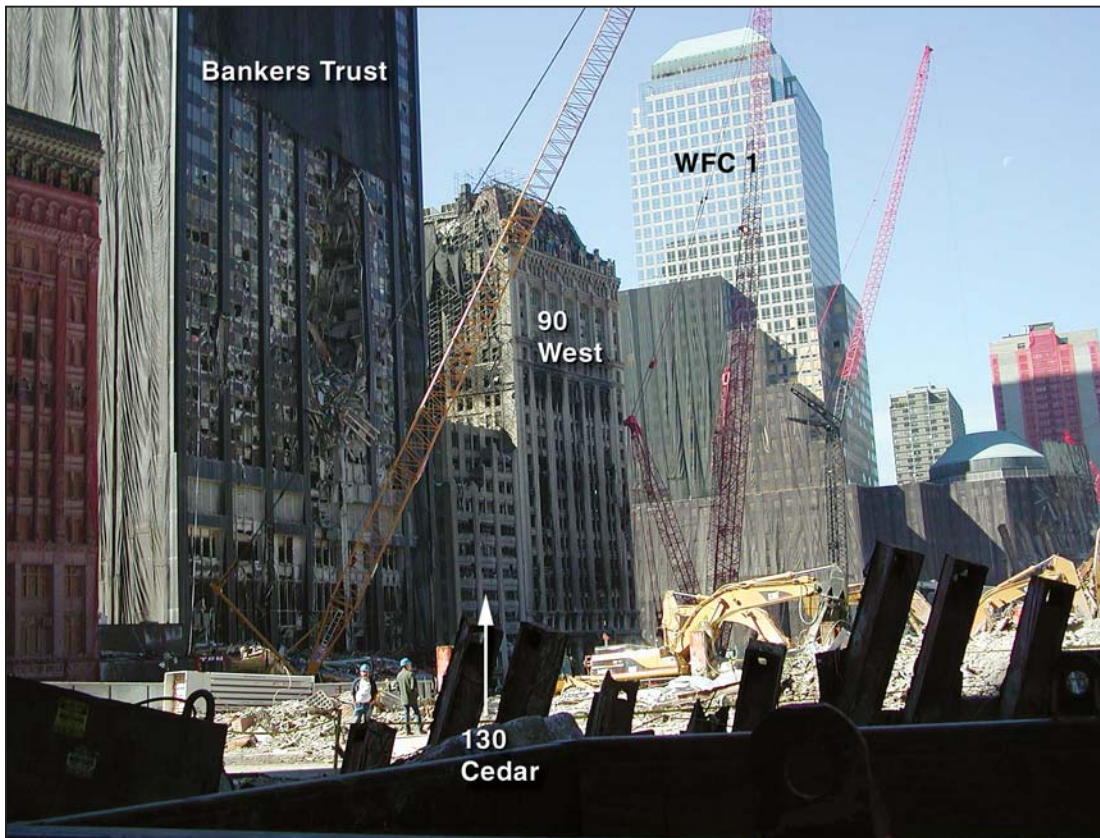
Figure 7-14 130 Cedar Street and 90 West Street.

Some façade damage was noted (primarily to the parapets), but most of the damage occurred at the roof level where the slab of the northeast corner collapsed under debris with the column capitals punching through the slab. A column section from WTC 2 penetrated the 10th floor roof slab. The southern portion of the building was not damaged. Structural damage from projectile impact and fire occurred primarily above the 9th floor. Fire damage was evident on the 11th and 12th floors in the northwest corner. Several concrete columns were cracked, possibly from the impact. Several bays at the northeast corner were severely damaged from debris impact. Concrete samples from two fire locations indicated that the concrete structure may have experienced fire temperatures of between 315 °C (600 °F) and 590 °C (1,100 °F). Spalling of capitals was observed in the fire areas.

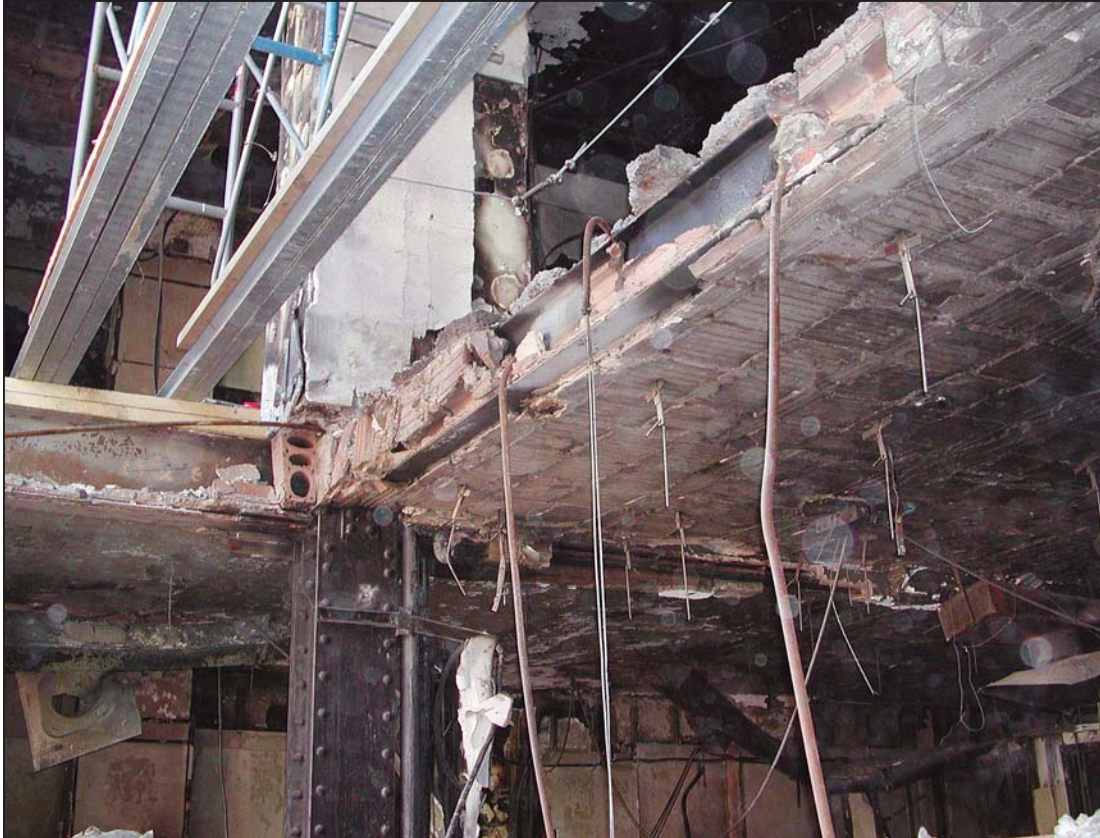
The riveted steel framing consists of rolled and built-up sections for the columns and beams. Columns are spaced approximately 18 feet apart. The primary framing runs north-south, with secondary members in the east-west direction. Lateral load resistance is provided primarily by partial-strength, partially restrained moment connections of frame members and the infill masonry walls. The floor slabs of terra cotta flat arches appeared to be topped with low-strength cinder-concrete. Terra cotta and masonry enclosures provided fireproofing for all original architectural areas and structural elements. The building construction is shown in Figure 7-15.

Figure 7-15 Interior of 90 West Street showing typical construction features.

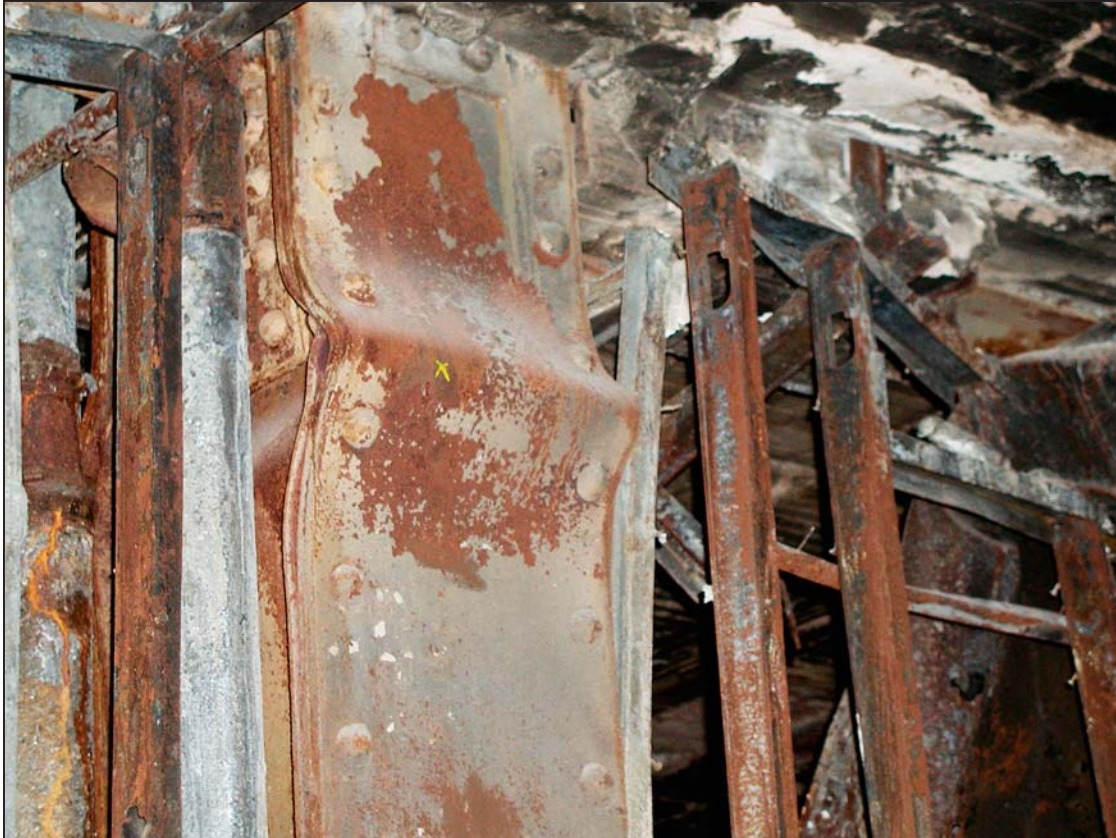
fire load, is considered typical for this type of construction and fire protection; however, it has been suggested that the scaffolding that was in place for renovations contributed to the spread of fire between floors that may not have occurred otherwise. However, the only structural damage observed was buckling damage near the tops of two columns.

Figure 7-17 Buckling damage at top of column on floor 23 of 90 West Street.

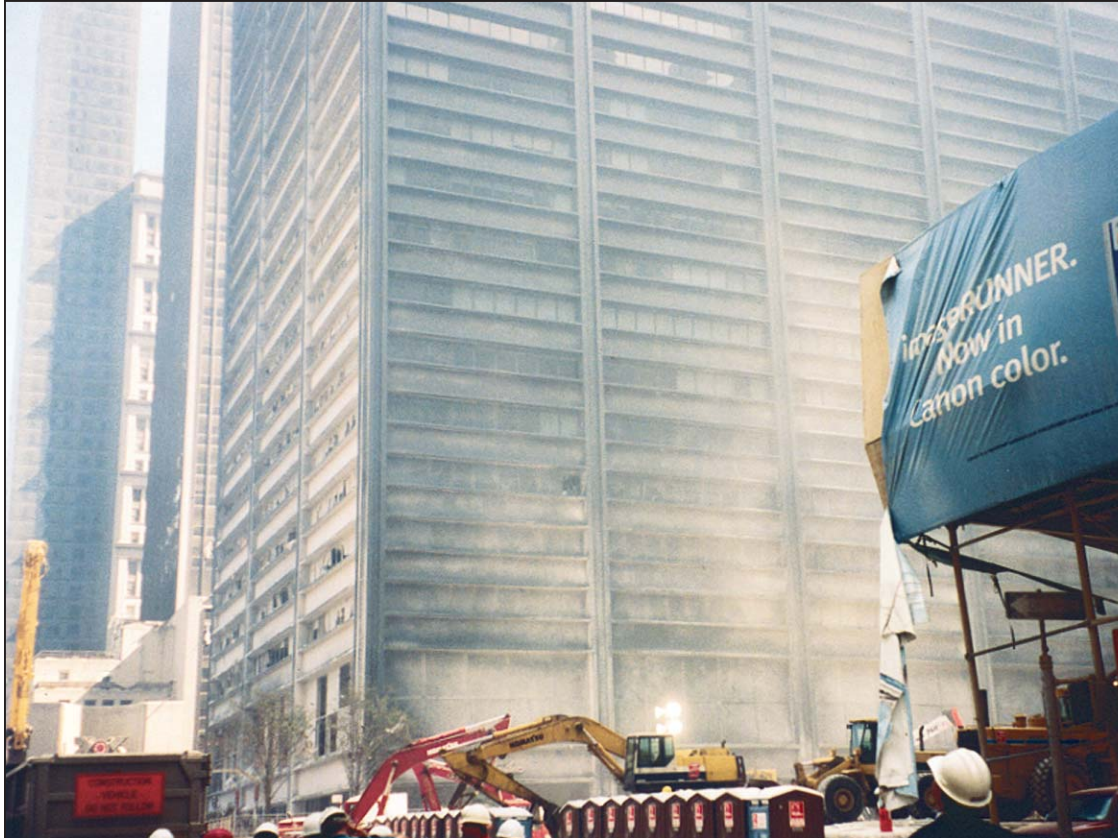
The majority of damage incurred at One Liberty consisted of broken window glass and frames. Most of that broken glass was in the lower six floors of the west-facing elevation, with less breakage on the floors above. There was, however, some broken glass on the north- and south-facing elevations as well. At those elevations, most of the broken glass was located at floors 1 through 6. There were approximately 550 broken lites of glass, and approximately 200 frames were damaged beyond repair.

Figure 7-18 One Liberty Plaza – south elevation, lower floors.

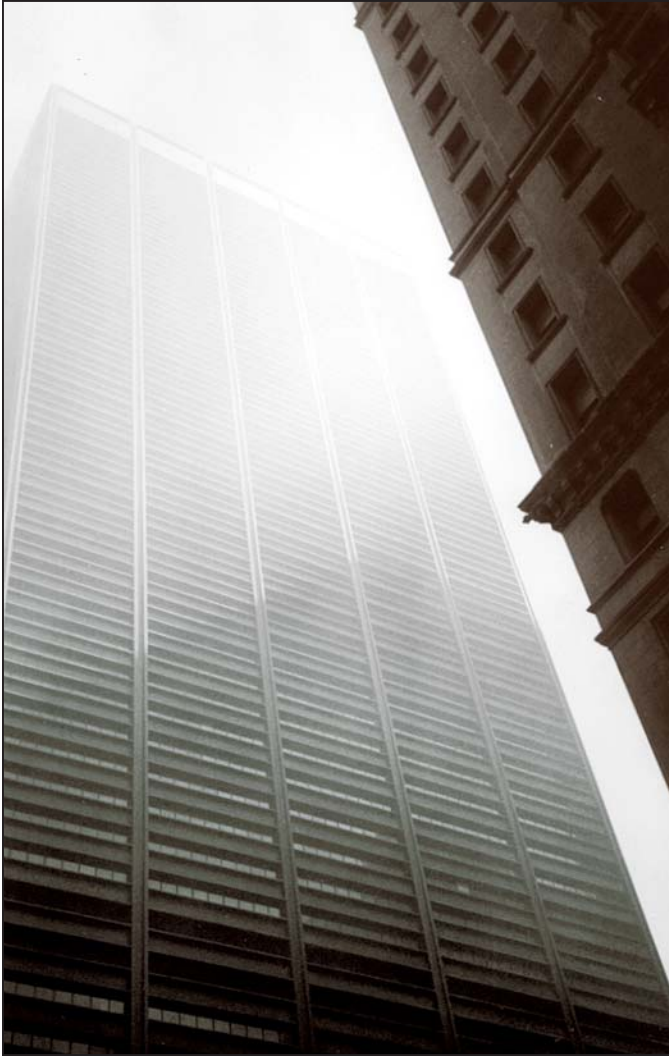
*Figure 7-19*  
*One Liberty Plaza – south elevation, upper floors.*
